SULTAN MIZAN ZAINAL ABIDIN STADIUM ROOF COLLAPSE, KUALA TERENGGANU, MALAYSIA (LACK OF SAFETY ISSUES)

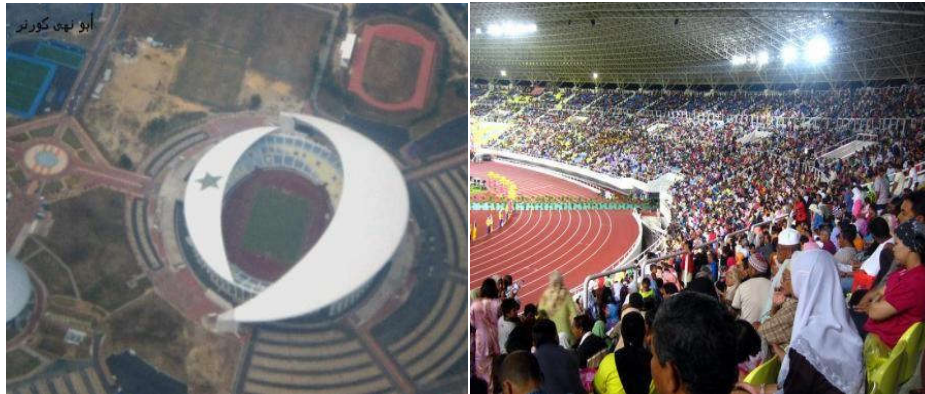
Sultan Mizan Zainal Abidin Stadium is a multi-purpose stadium in Kuala Terengganu, Malaysia, constructed by a South Korean construction firm. Together with the adjacent Mini Stadium, it forms the centre piece of Terengganu Sports Complex. It was used mostly for football matches. The stadium holds 50,000 people and is named after the reigning Terengganu Ruler, Sultan Mizan Zainal Abidin.⁵ Billed as the pride of the state, the RM300mil Sultan Mizan Zainal Abidin Stadium in Gong Badak suffered a major blow when its roof collapsed - just a year after it was opened. No one was injured in the 9am incident;⁶ it was then that massive steel roof over half of the stands collapsed, being destroyed completely. There was no-one inside, but the failure could have easily harm many people since the capacity of the stadium is 50000, so only a few cars parked outside were destroyed, but the stadium, which was the venue for sukma (Malaysian Games), last year has been declared unsafe.⁶ The roof on the stadium's left wing was ravaged after the iron frame structure supporting the 300m-long roof destabilized, causing it to fold. The affected zones were the main entrance, royal podium and the public seating area.⁵

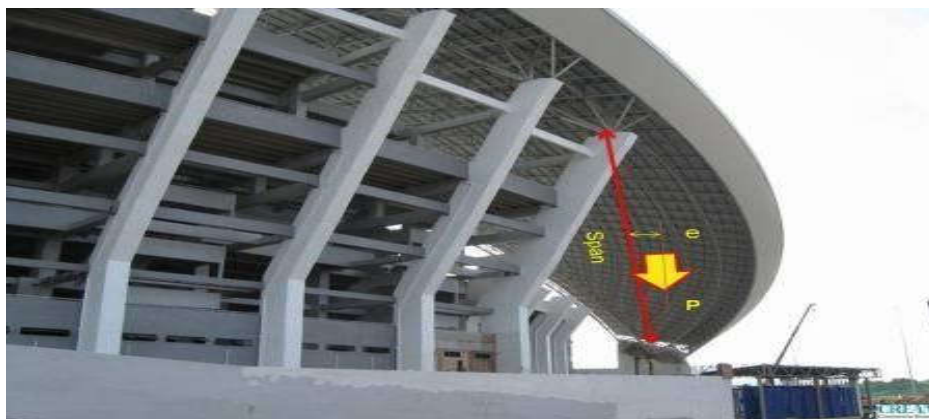
The design and construction of the building had been on an extremely fast passed schedule to insure the stadium was ready for the 2008 Sukma Games. The roof structure design was also changed to the light frame steel structure very late in the design meaning the time spent designing it was questionable at best. Prior to the collapse problems with the structure of the roof had already begun. Damage in the frames of the roof along with bang like noises coming from the roof had been observed. Ironically repairs for the roof were actually scheduled for the exact day in which the roof fall down.^{5,7}

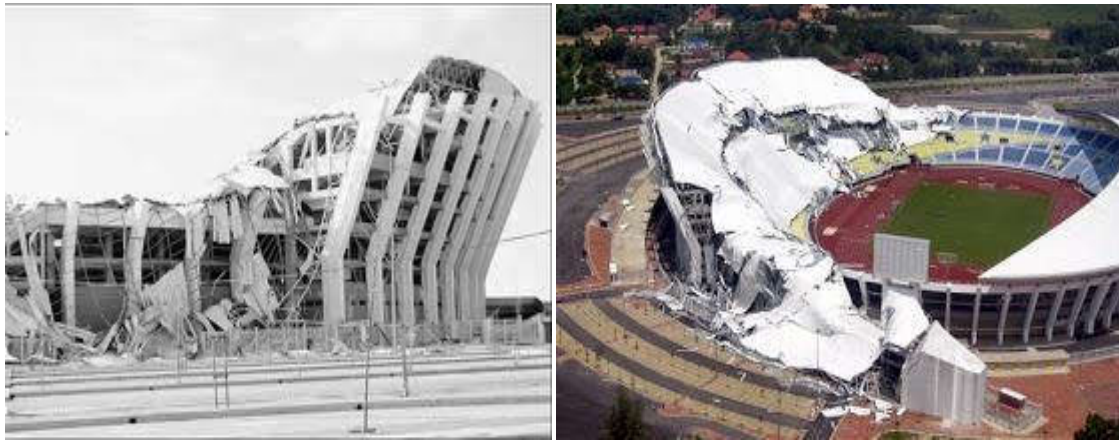
At 9am in the morning workers were doing their normal cleaning and maintenance when they heard a huge crashing sound. The supports at the outside of the stadium that held up the enormous cantilevered roof had failed and the roof had fallen on to the stadiums seating below. Luckily the workers in the stadium were not under the roof and no one was hurt

in the collapse. A few vehicles outside the stadium were damaged by the debris. The collapse started at the almost 100 foot span from the edge of the stadium to the concrete buttress holding up the end of the crescent shape. This caused the supports attached to the outside of the stadium then proceeded to fail, resulting in the entire half of the roof to fall and cover the entire seating area below. The collapse of the roof not only damaged seating but also the main entrance to the stadium and the royal box.^{5,7}

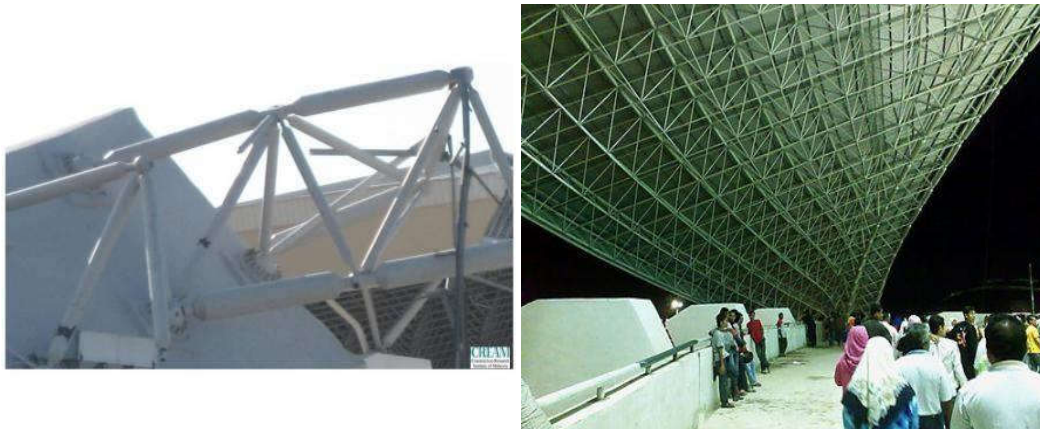
TMZA Stadium is designed to have two shell-like roofs supported by concrete buttress and space trusses. Steel columns attached to concrete stumps support the space trusses along the roof while at its two ends; a concrete buttress at each is implemented. Between the end of the steel column and the buttress there exists a wide gap spanning more than 30 m. The truss consists of tubular and steel ball joints. Prior to the collapse, they were reports of structure damage and sporadic loud bangs. A structural repair job was scheduled to be done on the day of the collapse. A year after opening ceremony, the roof collapsed during a day of typical Malaysian weather (hot and humid with temperature of about 28 Celsius). Roughly 60% of the roof including the section above the royal box collapsed.^{8,9}

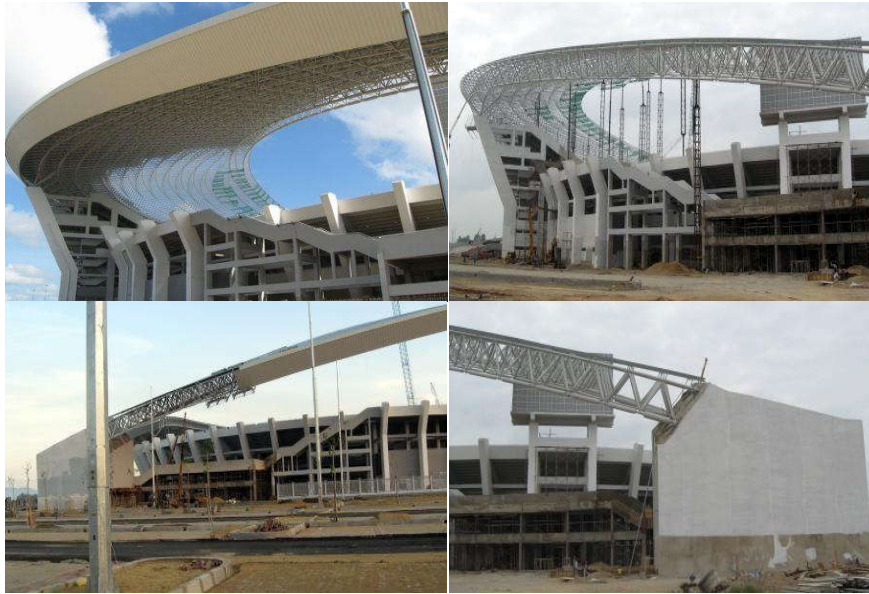
Besides that, the long gap between the last concrete stump and the concrete buttress was about 30 m wide. There was not enough support for the large magnitude of force from its own weight. In addition to that, buckling occurred in the inclined members (tube), a sign of load exceeding buckling capacity. Pullout of threaded screws out of the steel ball joints can also be observed after the incident. This means that they have been subjected to load beyond their capacities resulting in failure.⁹

The complex design of the roof and the wide span required more detailed analysis. Other factors that contributed to the stated damage are defective welding in steel components implying poor workmanship and strength of the materials used did not achieve design requirement when tested in preliminary tests thus reducing the mechanical strength of the structure. The roof was also erected poorly causing terrible geometry and thus, catastrophic force distribution along the structure. Non-technical cause includes lack of quality control and safety measures by project management team which causes mistakes to go unnoticed in their early stage.^{9, 10, and 11}

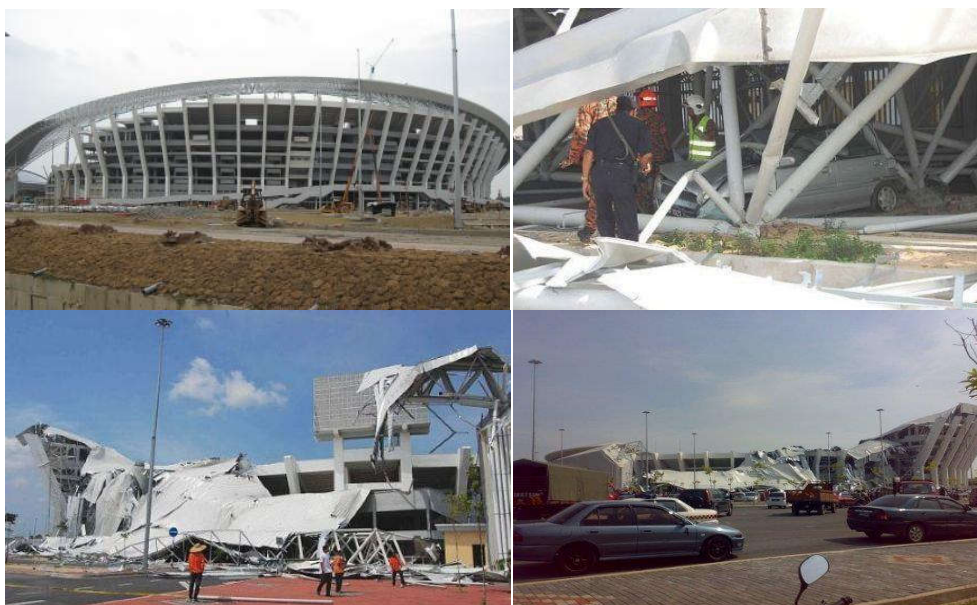
Defective welding in steel components, reflecting the poor quality of manufacturing or pre-fabrication work, poorly conceived erection method in installing the roof structural components, and no checks were conducted during the interim stages in erection. Inadequate temporary supports used. No apparent quality control by the project management team. Alternative design proposals provided by main contractor were adopted without integrated checks. Preliminary testing of materials used show strengths below design requirements, not meeting specification.^{11, 12}

The above factors have contributed largely to the collapse by causing a reduction in the safety factor of the structure – which was well below the norms required of such designs. Hence, it can be observed that the quality checks and control system were not properly planned and implemented, not only at the job sites but also in the design and planning office by the management team.^{11, 13, and 16}
