## SULTAN MIZAN ZAINAL ABIDIN STADIUM ROOF COLLAPSE, KUALA TERENGGANU, MALAYSIA (LACK OF SAFETY ISSUES)

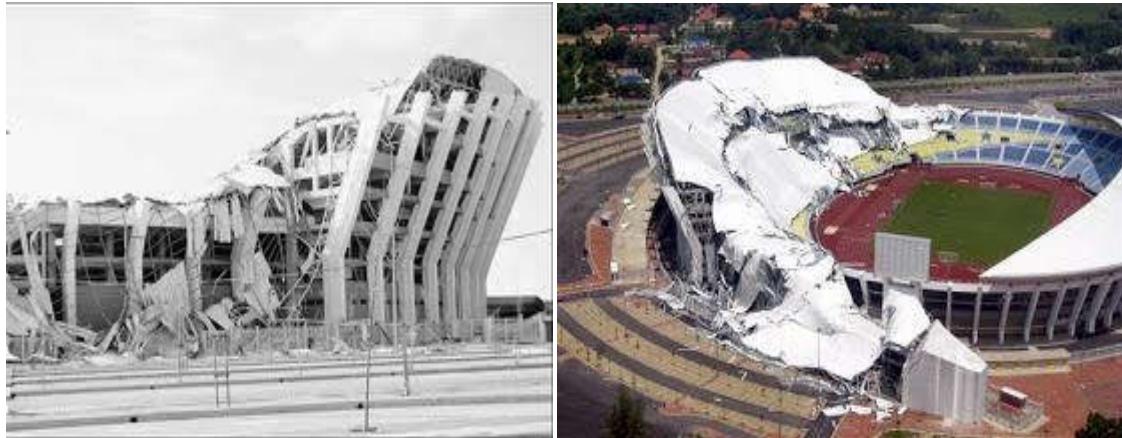
At 9am in the morning workers were doing their normal cleaning and maintenance when they heard a huge crashing sound. The supports at the outside of the stadium that held up the enormous cantilevered roof had failed and the roof had fallen on to the stadiums seating below. Luckily the workers in the stadium were not under the roof and no one was hurt

in the collapse. A few vehicles outside the stadium were damaged by the debris. The collapse started at the almost 100 foot span from the edge of the stadium to the concrete buttress holding up the end of the crescent shape. This caused the supports attached to the outside of the stadium then proceeded to fail, resulting in the entire half of the roof to fall and cover the entire seating area below. The collapse of the roof not only damaged seating but also the main entrance to the stadium and the royal box.<sup>5, 7</sup>

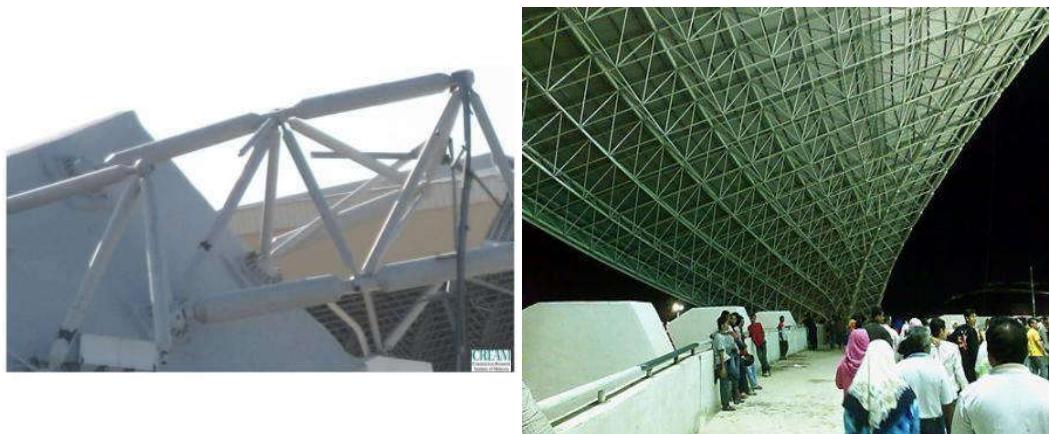
TMZA Stadium is designed to have two shell-like roofs supported by concrete buttress and space trusses. Steel columns attached to concrete stumps support the space trusses along the roof while at its two ends; a concrete buttress at each is implemented. Between the end of the steel column and the buttress there exists a wide gap spanning more than 30 m. The truss consists of tubular and steel ball joints. Prior to the collapse, there were reports of structure damage and sporadic loud bangs. A structural repair job was scheduled to be done on the day of the collapse. A year after opening ceremony, the roof collapsed during a day of typical Malaysian weather (hot and humid with temperature of about 28 Celsius). Roughly 60% of the roof including the section above the royal box collapsed.<sup>8, 9</sup>

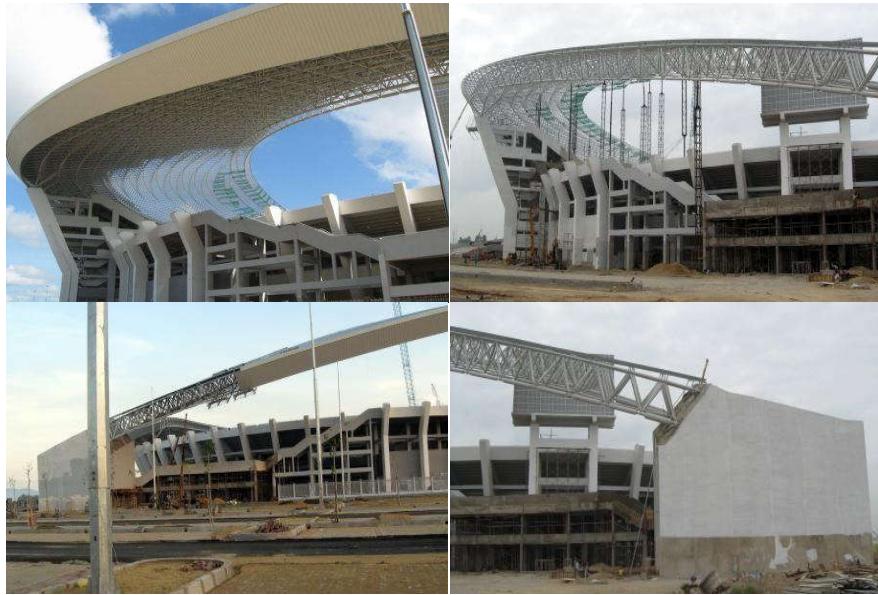
Besides that, the long gap between the last concrete stump and the concrete buttress was about 30 m wide. There was not enough support for the large magnitude of force from its own weight. In addition to that, buckling occurred in the inclined members (tube), a sign of load exceeding buckling capacity. Pullout of threaded screws out of the steel ball joints can also be observed after the incident. This means that they have been subjected to load beyond their capacities resulting in failure.<sup>9</sup>

The complex design of the roof and the wide span required more detailed analysis. Other factors that contributed to the stated damage are defective welding in steel components implying poor workmanship and strength of the materials used did not achieve design requirement when tested in preliminary tests thus reducing the mechanical strength of the structure. The roof was also erected poorly causing terrible geometry and thus, catastrophic force distribution along the structure. Non-technical cause includes lack of quality control and safety measures by project management team which causes mistakes to go unnoticed in their early stage.<sup>9, 10, and 11</sup>

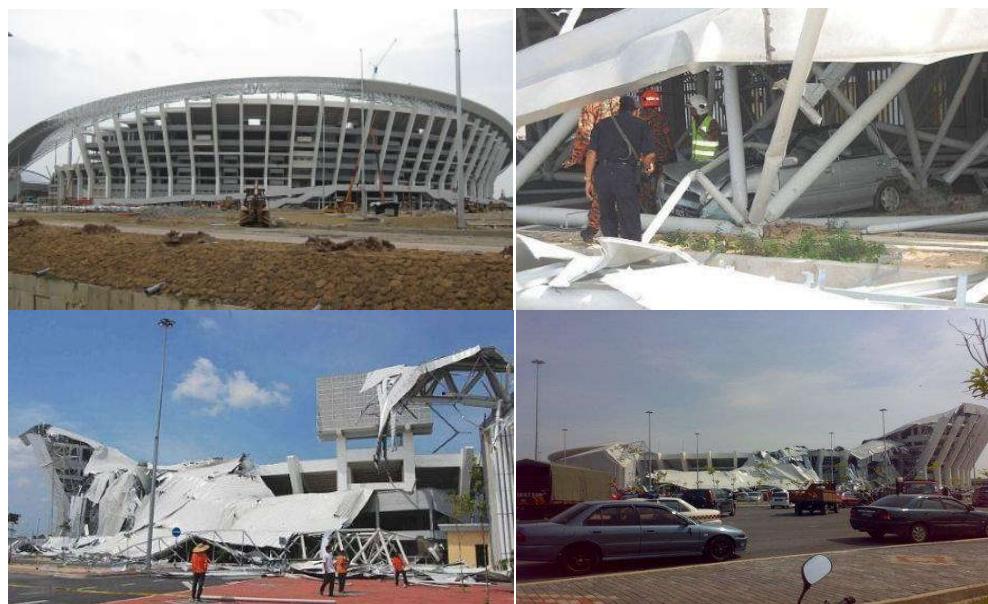
Defective welding in steel components, reflecting the poor quality of manufacturing or pre-fabrication work, poorly conceived erection method in installing the roof structural components, and no checks were conducted during the interim stages in erection. Inadequate temporary supports used. No apparent quality control by the project management team. Alternative design proposals provided by main contractor were adopted without integrated checks. Preliminary testing of materials used show strengths below design requirements, not meeting specification.<sup>11, 12</sup>

The above factors have contributed largely to the collapse by causing a reduction in the safety factor of the structure – which was well below the norms required of such designs. Hence, it can be observed that the quality checks and control system were not properly planned and implemented, not only at the job sites but also in the design and planning office by the management team.<sup>11, 13, and 16</sup>
