SULTAN MIZAN ZAINAL ABIDIN STADIUM ROOF COLLAPSE, KUALA TERENGGANU, MALAYSIA (LACK OF SAFETY ISSUES)

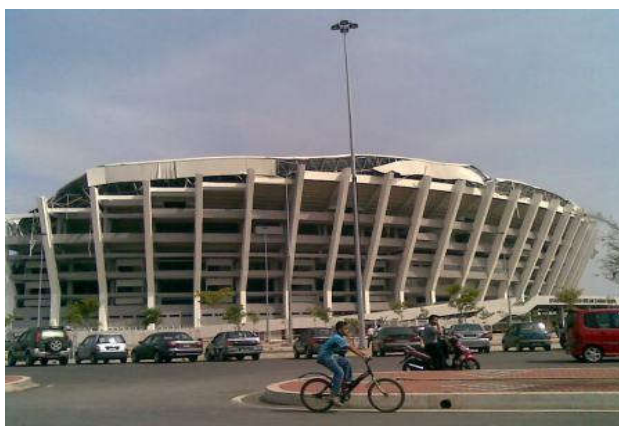
Issue of concern is why so many incidents are happening with a safety problem in construction industry. These reported incidents have brought into question the subject of construction safety which must be looked into seriously by the relevant authority in the interest of public safety.^{14, 15} The truly sad part about this collapse is that it was entirely preventable. There was no crazy weather phenomenon or act of god that caused this it was simply a case of complete and total failure from design to construction.^{15, 16}

Many of the failure causes can be eliminated if the engineers and workers comply with the ethical guidelines and prioritize the public safety instead of individual importance. More design proposals should be considered and determine whether or not it is within the capacities of the firm constructing the structure. They should also have not done the parts they are not competent and outsource it to specialty companies. The project should be halted and alterations should be made as soon as any sign of weakness is observed during the project as engineers, we should also use suitable material instead of the ones that didn't comply with the design need. Last but not least, quality inspection should be done from time to time to ensure the standards are followed.^{14, 17}
