## SULTAN MIZAN ZAINAL ABIDIN STADIUM ROOF COLLAPSE, KUALA TERENGGANU, MALAYSIA (LACK OF SAFETY ISSUES)

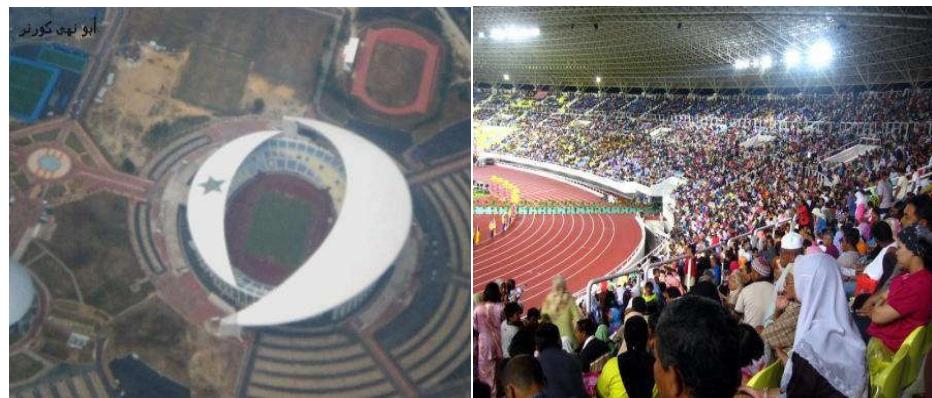
Sultan Mizan Zainal Abidin Stadium is a multi-purpose stadium in Kuala Terengganu, Malaysia, constructed by a South Korean construction firm. Together with the adjacent Mini Stadium, it forms the centre piece of Terengganu Sports Complex. It was used mostly for football matches. The stadium holds 50,000 people and is named after the reigning Terengganu Ruler, Sultan Mizan Zainal Abidin.<sup>5</sup> Billed as the pride of the state, the RM300mil Sultan Mizan Zainal Abidin Stadium in Gong Badak suffered a major blow when its roof collapsed - just a year after it was opened. No one was injured in the 9am incident;<sup>6</sup> it was then that massive steel roof over half of the stands collapsed, being destroyed completely. There was no-one inside, but the failure could have easily harm many people since the capacity of the stadium is 50000, so only a few cars parked outside were destroyed, but the stadium, which was the venue for sukma (Malaysian Games), last year has been declared unsafe.<sup>6</sup> The roof on the stadium's left wing was ravaged after the iron frame structure supporting the 300m-long roof destabilized, causing it to fold. The affected zones were the main entrance, royal podium and the public seating area.<sup>5</sup>

The damage at the east wing has been estimated at RM25mil.<sup>6</sup> the stadiums main usage would be to host the states football matches in the Malaysia Super League and was meant to replace the old Sultan Ismail Nasiruddin Shah Stadium.<sup>7</sup> Four years after the collapse, the fallen roof had been removed and workers were dismantling the rest of the roof that had not fallen. As they were working on February 20th 2013 the rest of the roof came crashing down this time injuring five workers. The workers had taken down almost all of the roofing and were working on taking down the steel space frame structure of the roof. Finally in spring of 2015 the stadium roofs were all gone and the stadium was partially reopened for football matches with only half of the stands open for seating. The games can also only be played during the day because the lights for the stadium were attached to the roof. The government hopes to redesign and construct the roofs to bring the stadium back to the standard that they had hoped for in 2008 when it was completed.<sup>7</sup>

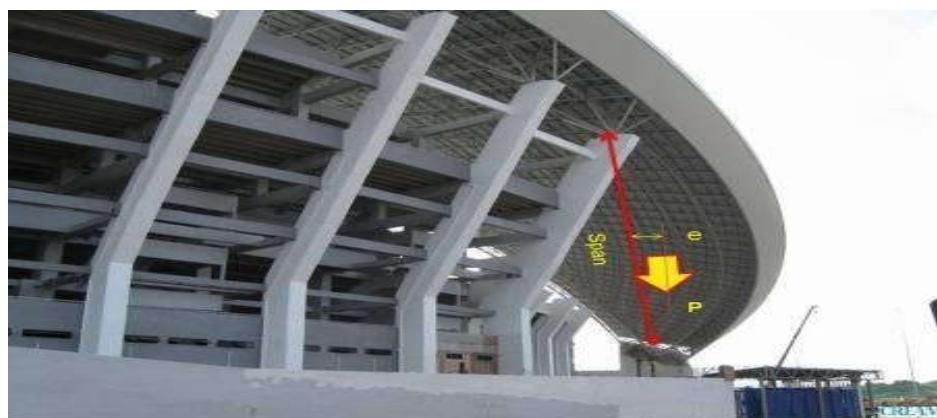
The design and construction of the building had been on an extremely fast passed schedule to insure the stadium was ready for the 2008 Sukma Games. The roof structure design was also changed to the light frame steel structure very late in the design meaning the time spent designing it was questionable at best. Prior to the collapse problems with the structure of the roof had already begun. Damage in the frames of the roof along with bang like noises coming from the roof had been observed. Ironically repairs for the roof were actually scheduled for the exact day in which the roof fall down.<sup>5, 7</sup>

At 9am in the morning workers were doing their normal cleaning and maintenance when they heard a huge crashing sound. The supports at the outside of the stadium that held up the enormous cantilevered roof had failed and the roof had fallen on to the stadiums seating below. Luckily the workers in the stadium were not under the roof and no one was hurt

in the collapse. A few vehicles outside the stadium were damaged by the debris. The collapse started at the almost 100 foot span from the edge of the stadium to the concrete buttress holding up the end of the crescent shape. This caused the supports attached to the outside of the stadium then proceeded to fail, resulting in the entire half of the roof to fall and cover the entire seating area below. The collapse of the roof not only damaged seating but also the main entrance to the stadium and the royal box.<sup>5, 7</sup>

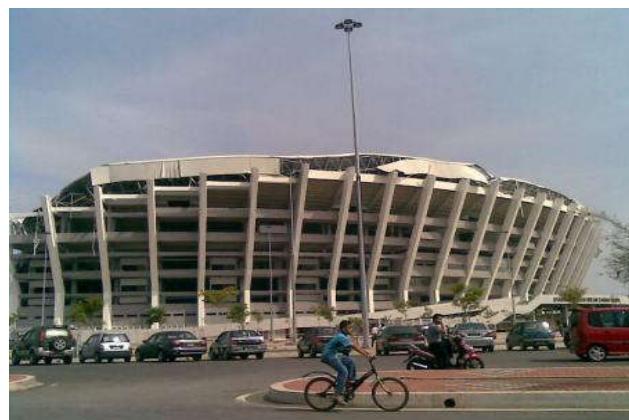
Issue of concern is why so many incidents are happening with a safety problem in construction industry. These reported incidents have brought into question the subject of construction safety which must be looked into seriously by the relevant authority in the interest of public safety.<sup>14, 15</sup> The truly sad part about this collapse is that it was entirely preventable. There was no crazy weather phenomenon or act of god that caused this it was simply a case of complete and total failure from design to construction.<sup>15, 16</sup>

Many of the failure causes can be eliminated if the engineers and workers comply with the ethical guidelines and prioritize the public safety instead of individual importance. More design proposals should be considered and determine whether or not it is within the capacities of the firm constructing the structure. They should also have not done the parts they are not competent and outsource it to specialty companies. The project should be halted and alterations should be made as soon as any sign of weakness is observed during the project as engineers, we should also use suitable material instead of the ones that didn't comply with the design need. Last but not least, quality inspection should be done from time to time to ensure the standards are followed.<sup>14, 17</sup>
